EXHIBIT E – Analysis of Markings on WTC 7 Steel Members

Markings on WTC Steel Which Identify Structural Members as of WTC 7

- Example #1: Column Line No. 38, Floors 9-11 Section (East Exterior Wall)

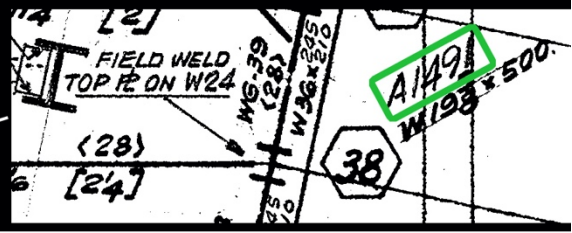
Excerpts from erection drawing sheet #10/11 (Frankel Steel, 1985) for floors 10-11.
Source: 911datasets.org / NIST_WTC7_FOIA_12-009

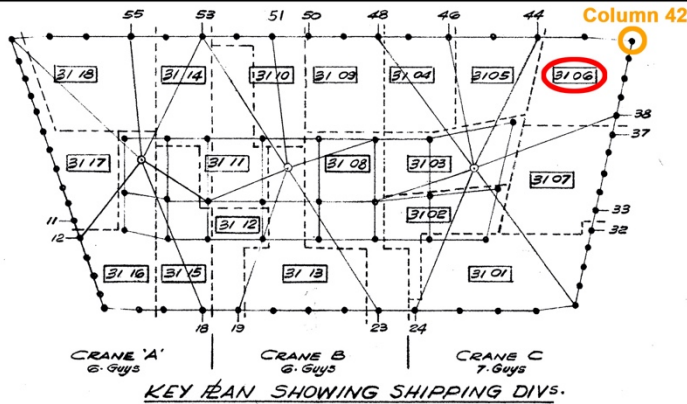
Two excerpts taken from erection drawing E30/31 for floors 30-31 (Frankel Steel, 1985).
 Source: 911datasets.org / NIST_WTC7_FOIA_12-009

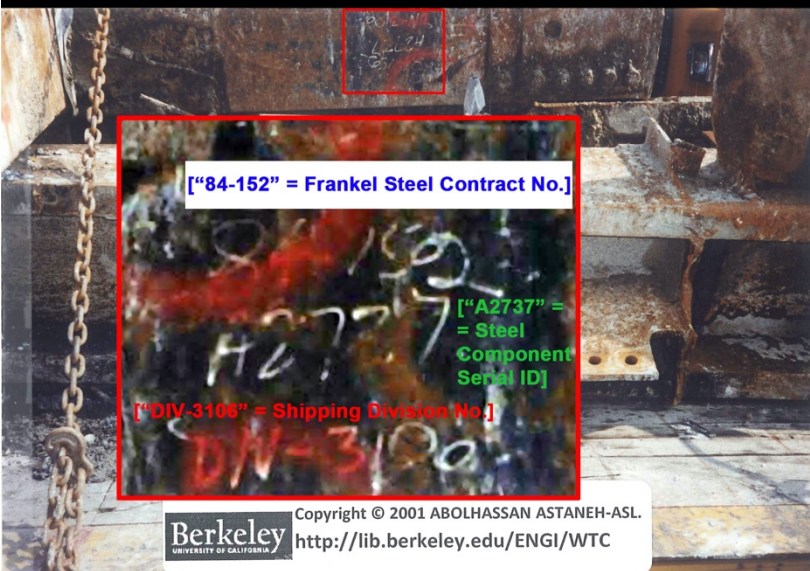
Steel columns lying on a flatbed truck located north of WTC site, near Church & Walker Streets. Original photo taken on Sept. 21, 2001 by Dr. Abolhassan Astaneh-Asl for his own small study "WTC Post-Disaster Reconnaissance and Perishable Structural Engineering Data Collection" (Sept. 2001-Sept. 2002), sponsored by the National Science Foundation. Released by Astaneh-Asl, among other images, in April 2014 through his Google Drive account at the inquiry of David Cole and Roger B.
 Download source: <https://drive.google.com/drive/folders/0B4-ljXL8uzWAciZLLVFPmU9yNDg?usp=sharing#list> (not publicly accessible) / File: 20140419131232922-final.pdf, PDF p. 20
